Westinghouse Astronuclear Laboratory

WANL-TNR-220

**NRX-A5 FINAL REPORT**

NRX-A5 Test Assembly Mated to Test Cell "A"

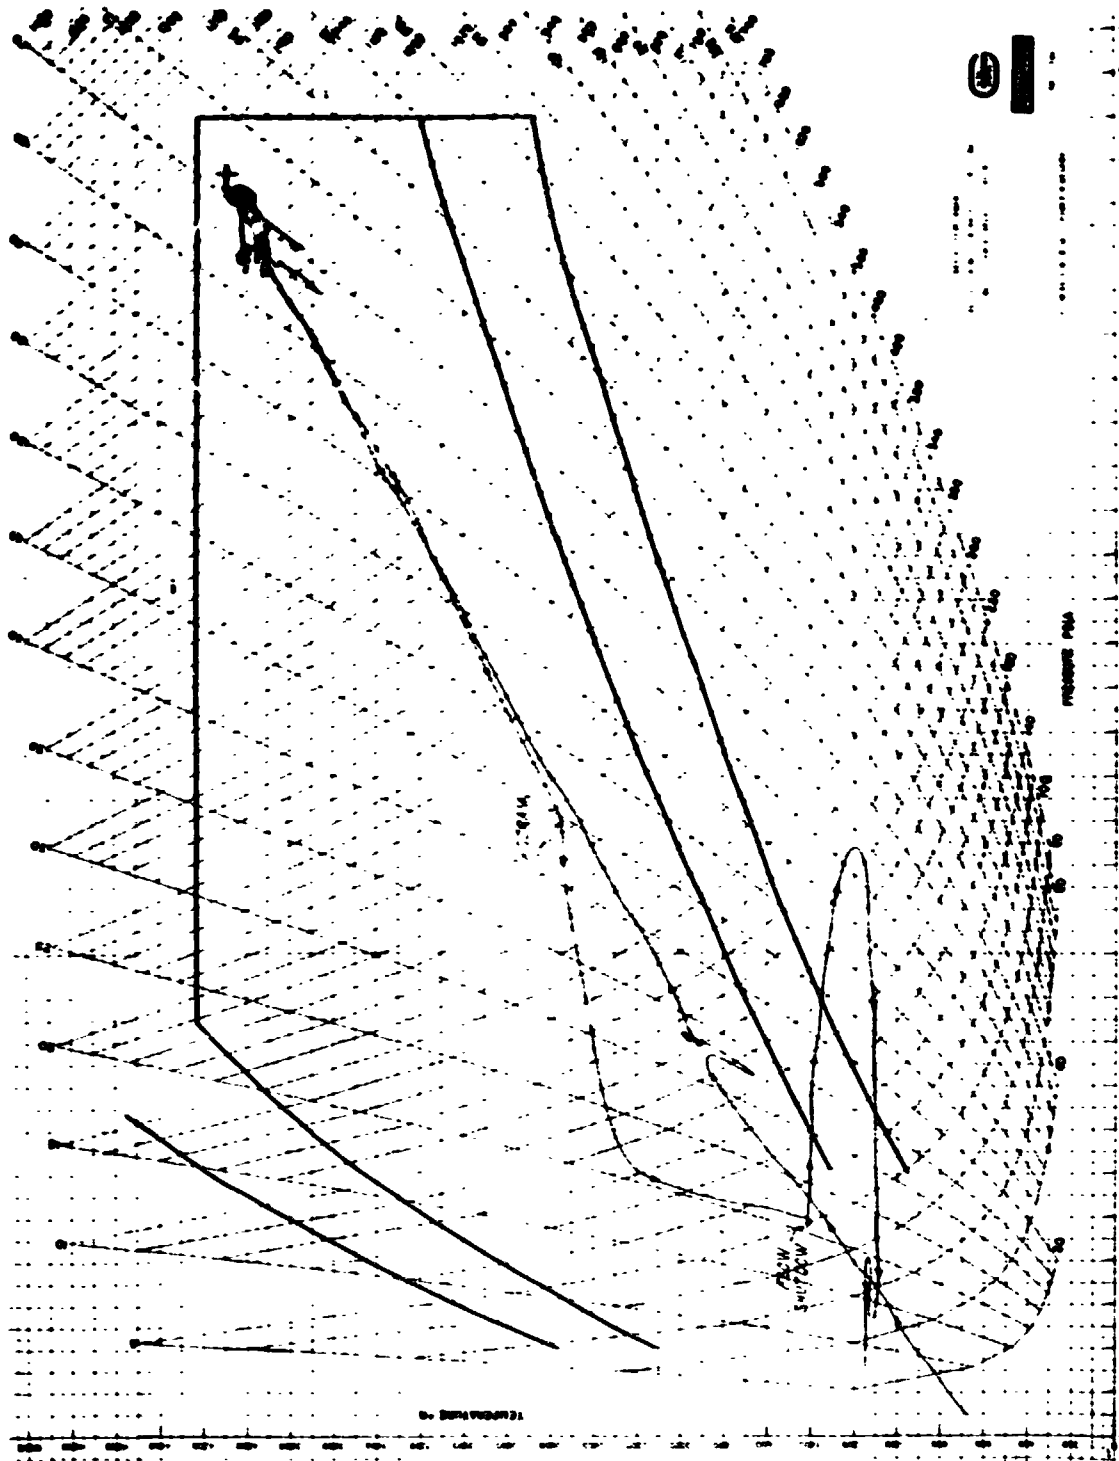
Figure 5. Reactor Performance Parameters During First Power Test (EP-III)

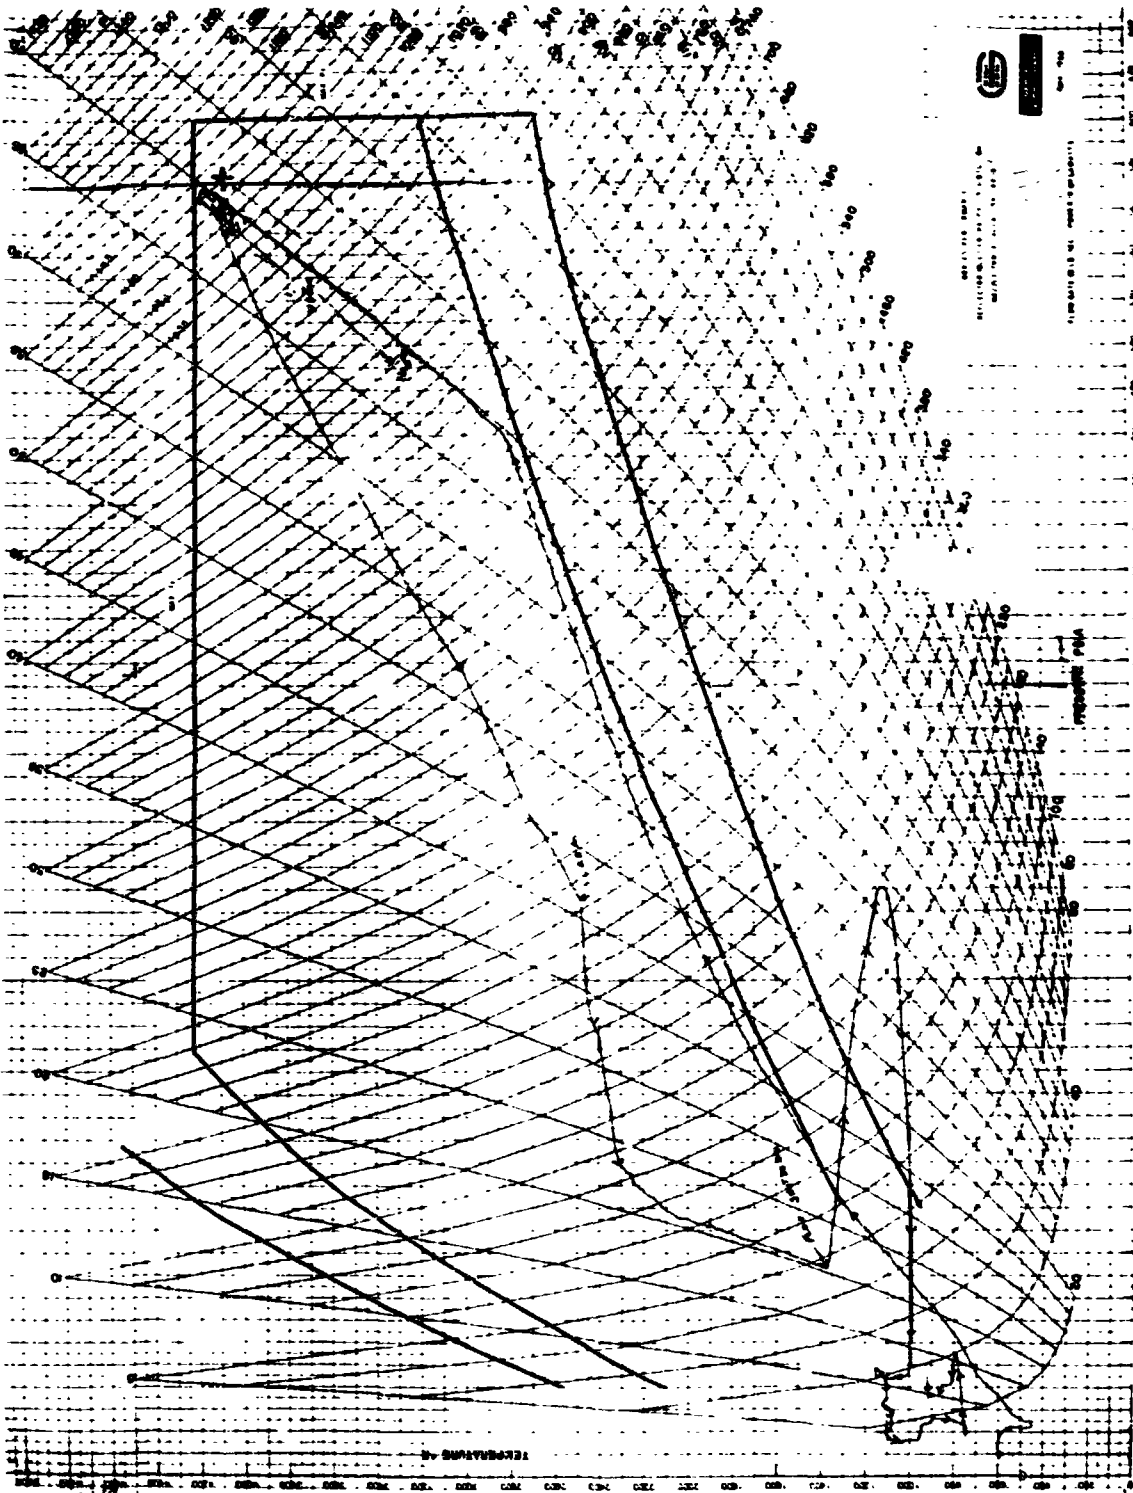
Figure 7. Reactor Performance Parameters During Second Power Test (EP-IV)

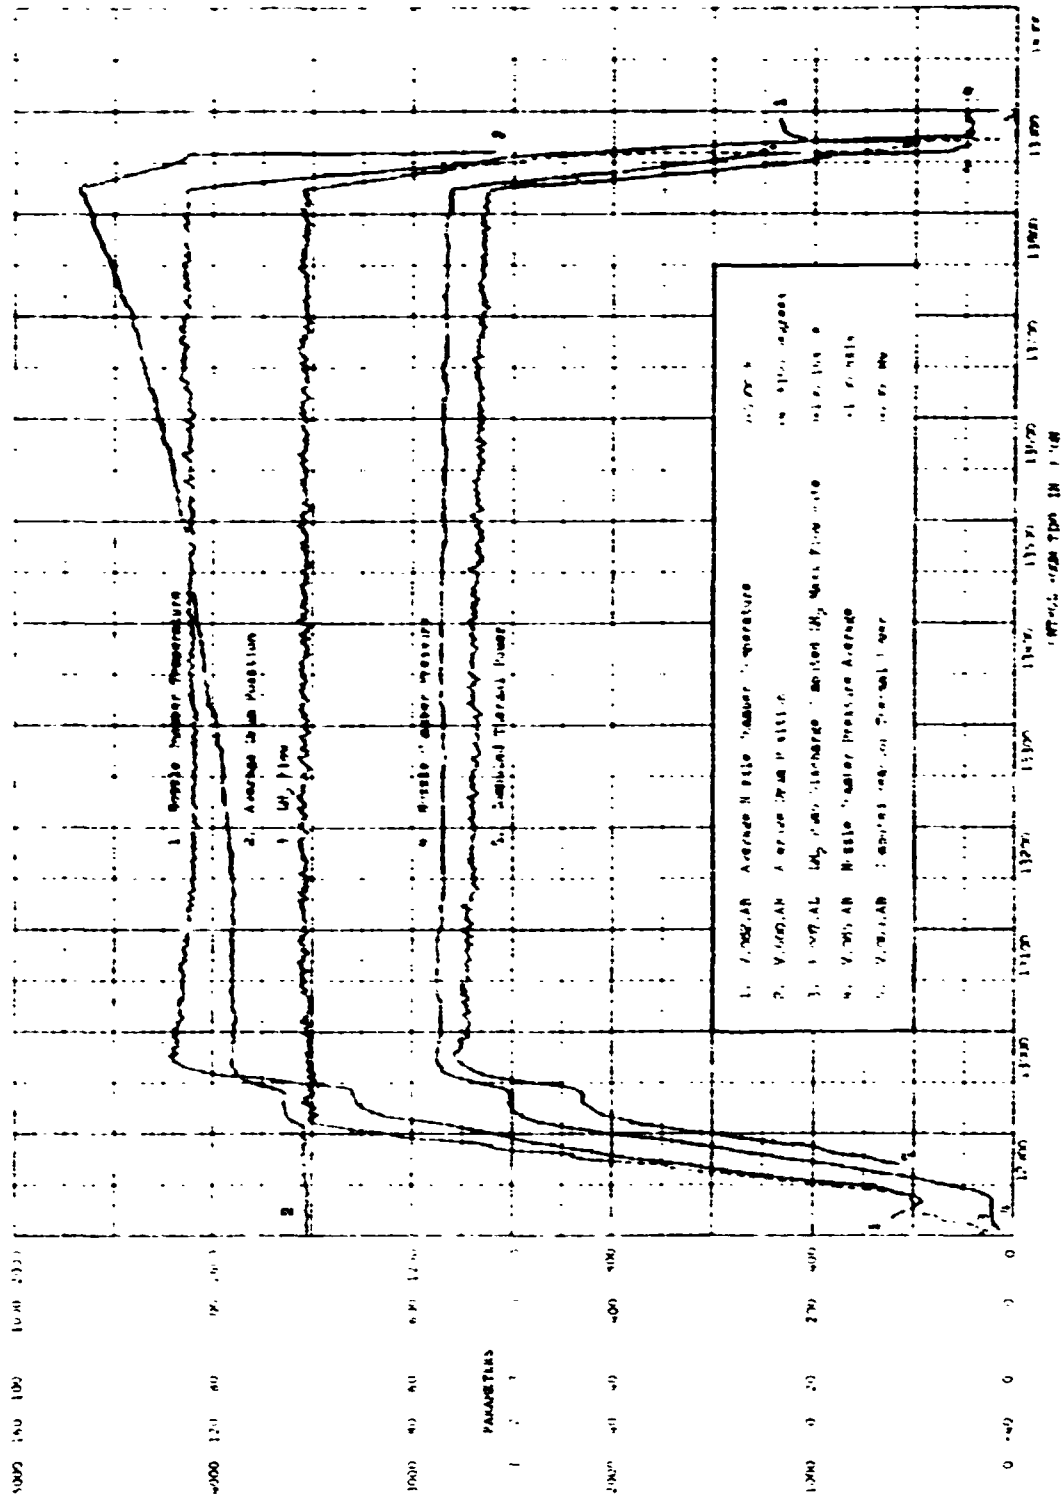
Figure 8. Reactor Operating Map for Second Power Test (EP-IV)

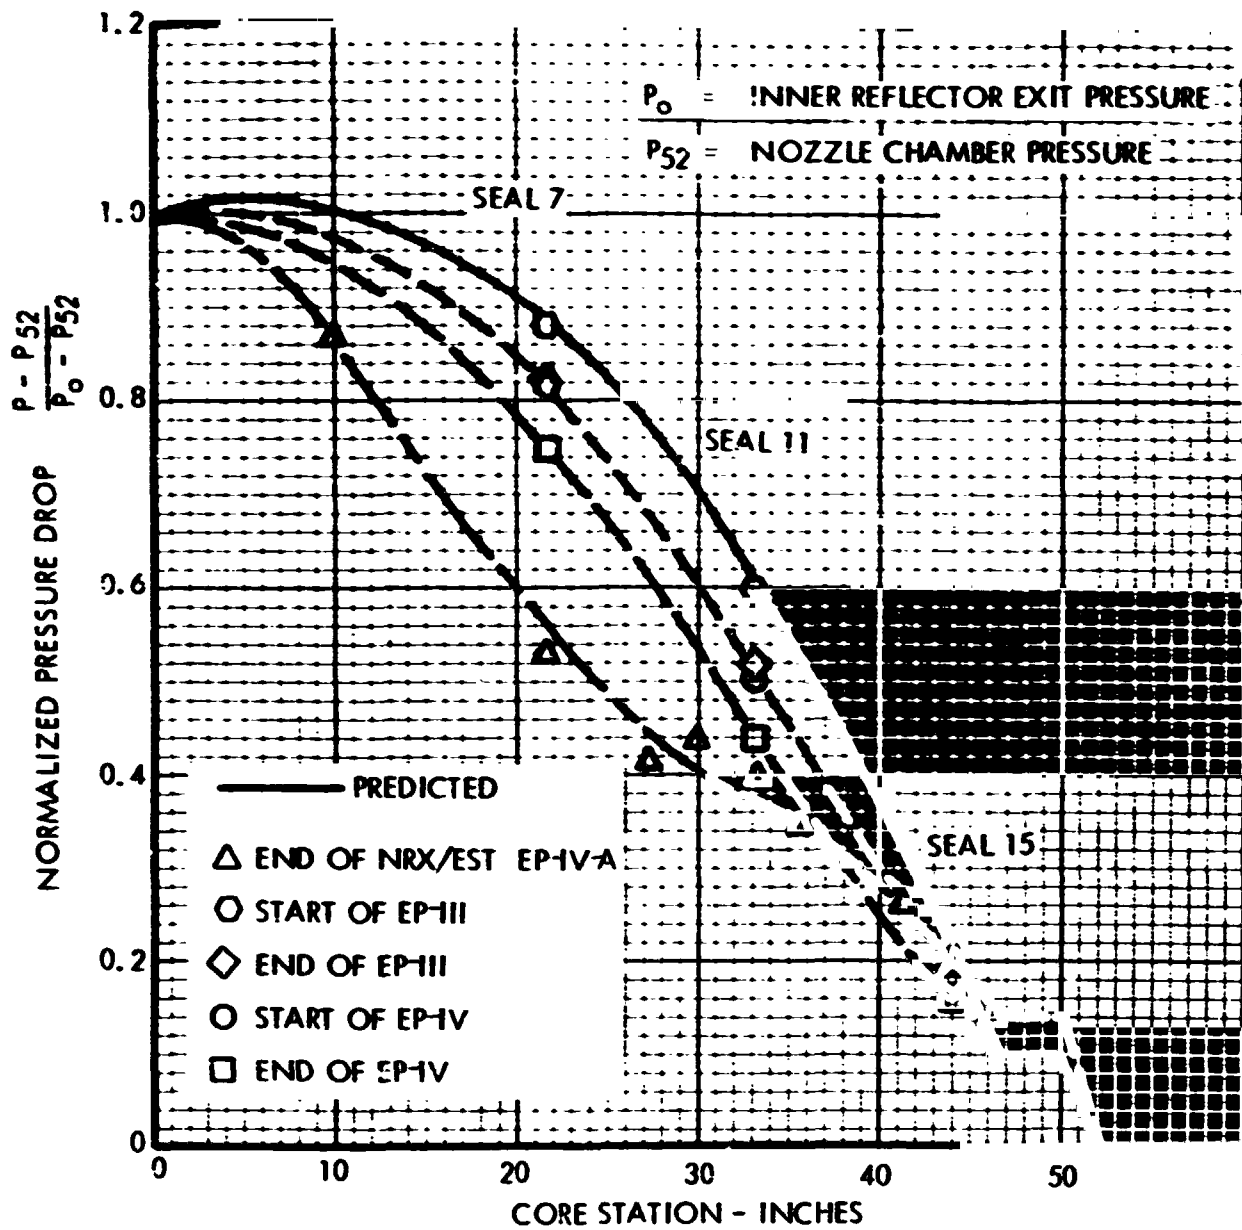
Figure 10. NRX-A5, Normalized Seal Chamber Pressure Profiles

At the start of the first full power endurance test the seal chamber coolant axial pressure distribution was the same as predicted, but as the test continued, the pressure at the core mid-band region decreased with test time, as shown on Figure 10, which compares the performance of the lateral support seal system in NRX-A5 and NRX/EST. The degradation of the seal chamber pressure was caused by core periphery corrosion which perturbed the coolant flow in the seal chambers.

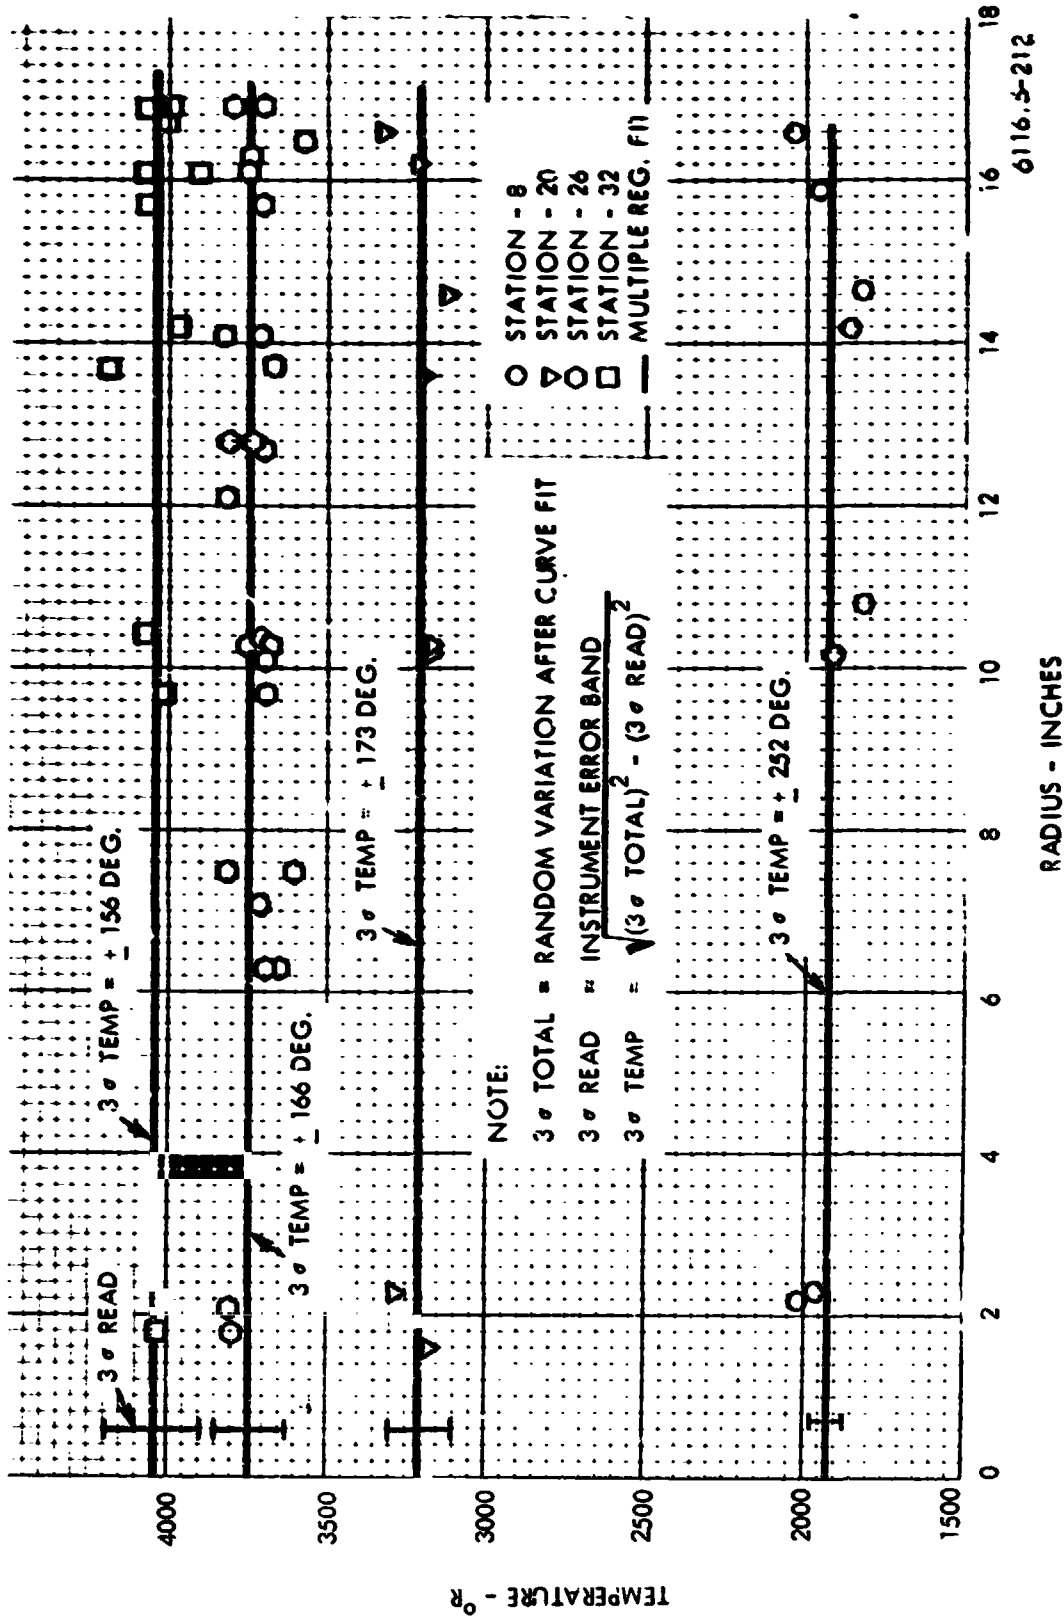
Figure II. NRX-A5, EP-III, Temperature Versus Radius

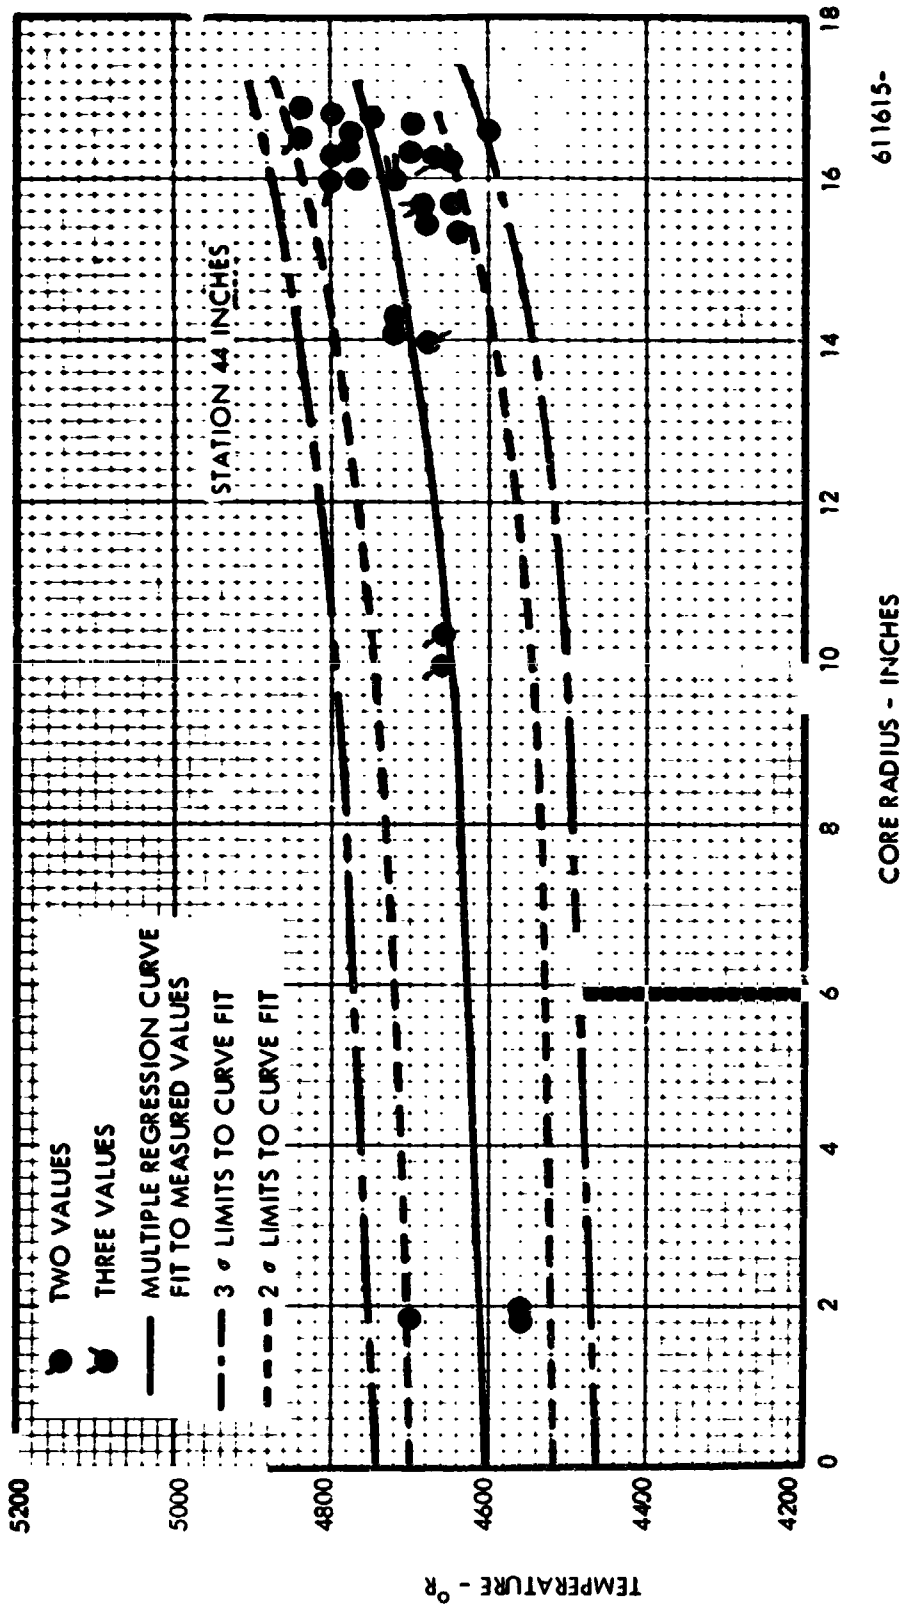
Figure 12. NRX-A5 Thermal Capsule Data Versus Core Radius

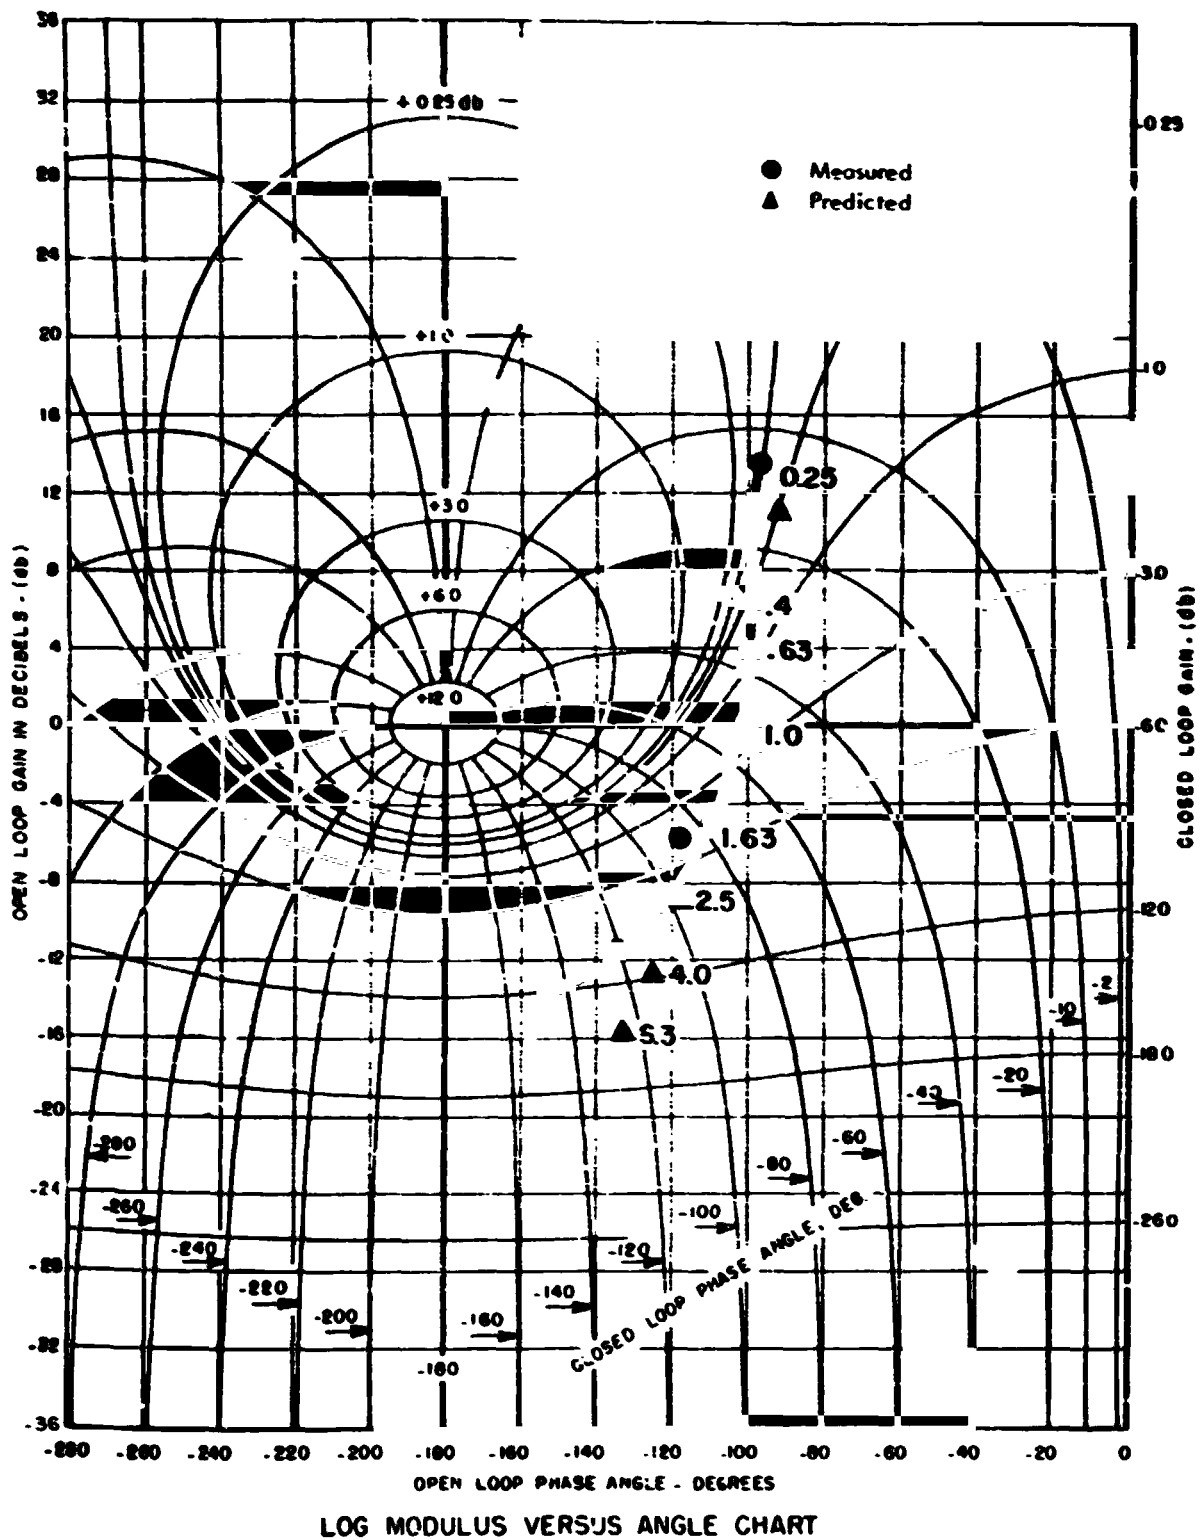
Figure 13. Measured Frequency Response of the Power Control Loop at 1 Kilowatt

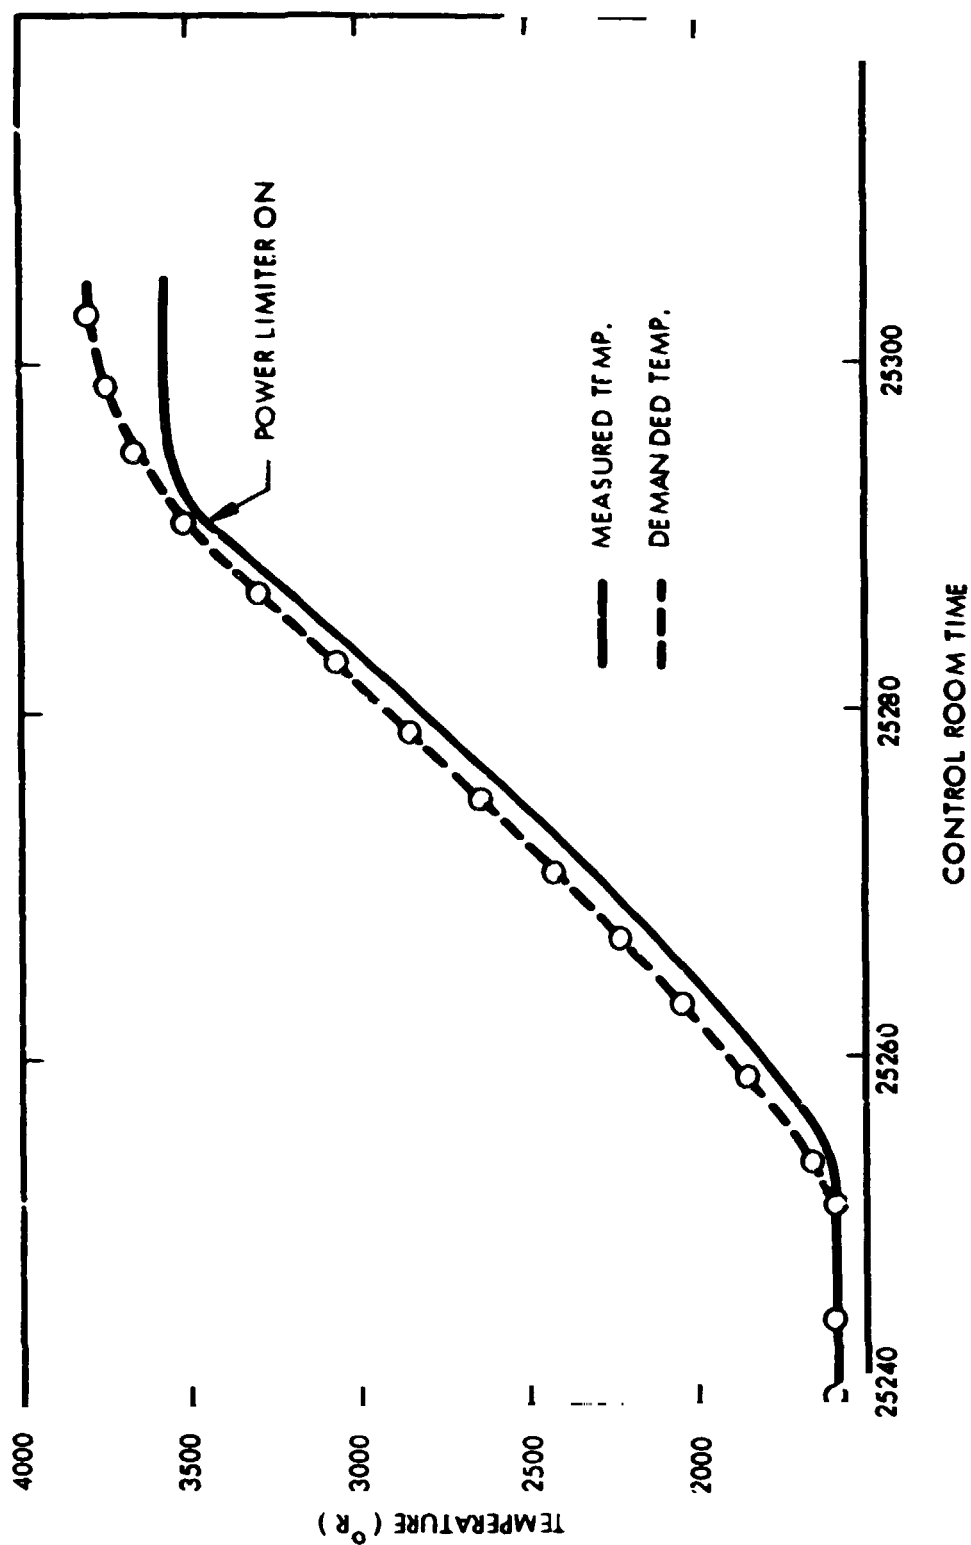
Figure 14. Station 26 Temperature Profile, EP-III Ramp from 2000°R Chamber Temperature to Design Conditions

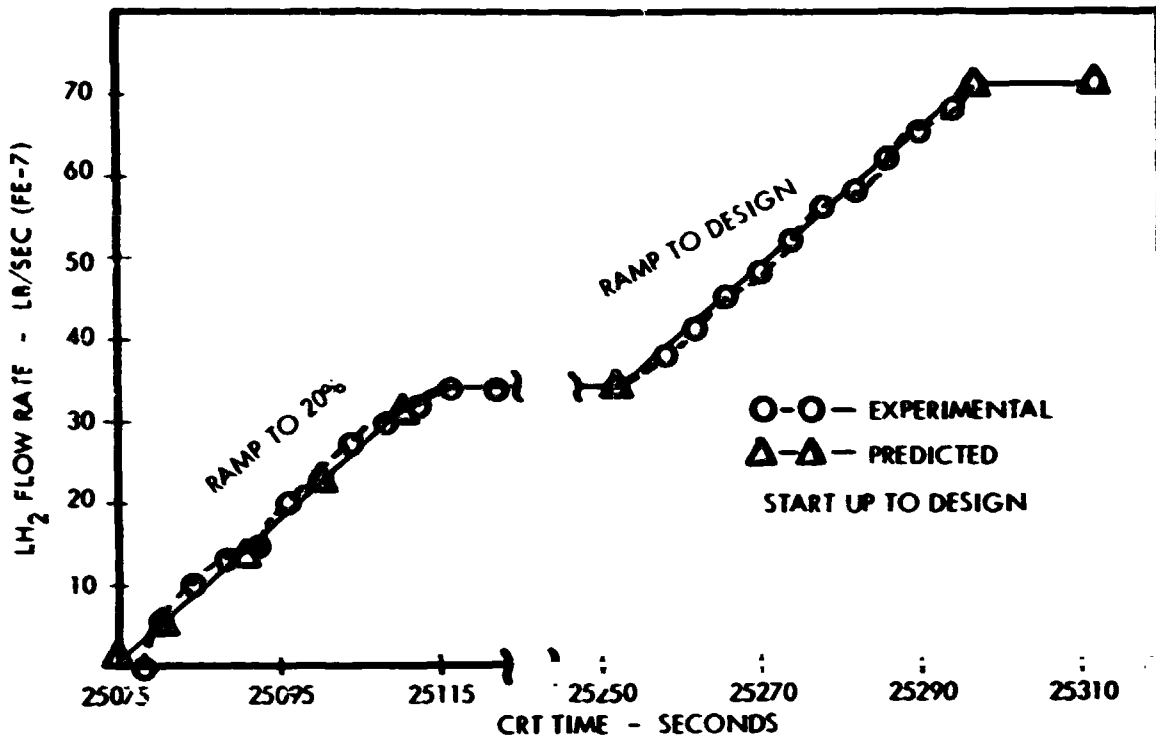
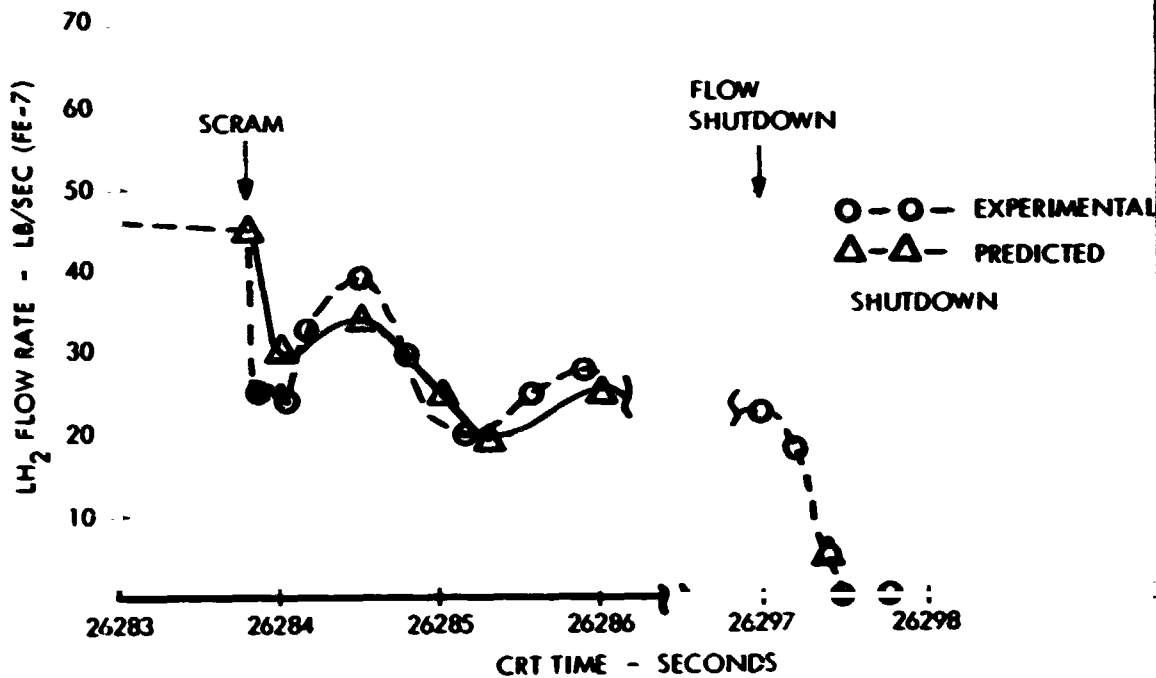
Figure 15. Pump Outlet Flow Rate Profile for EP-III

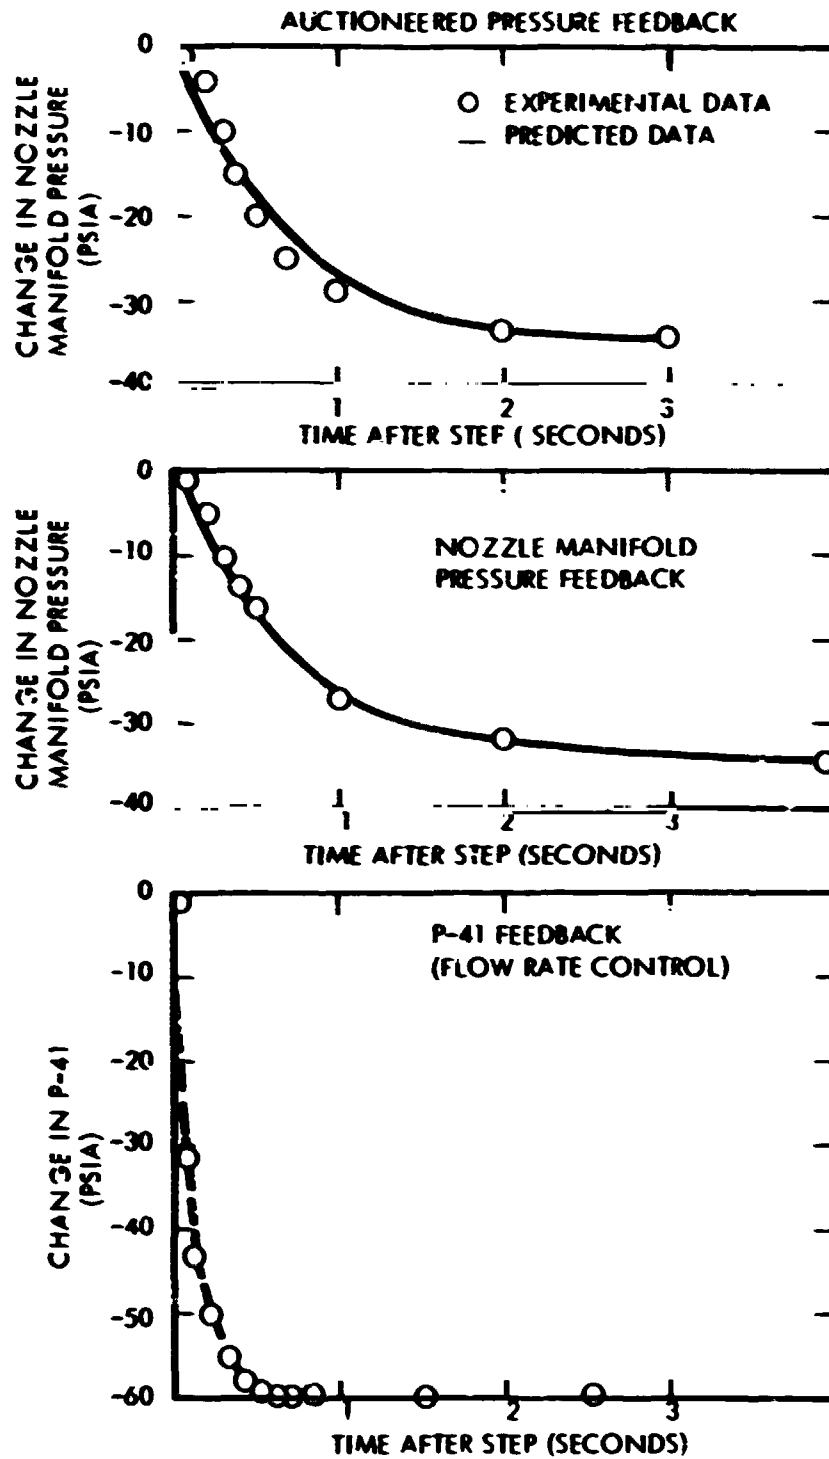
Figure 16. PCV-41 Step Responses During EP-1

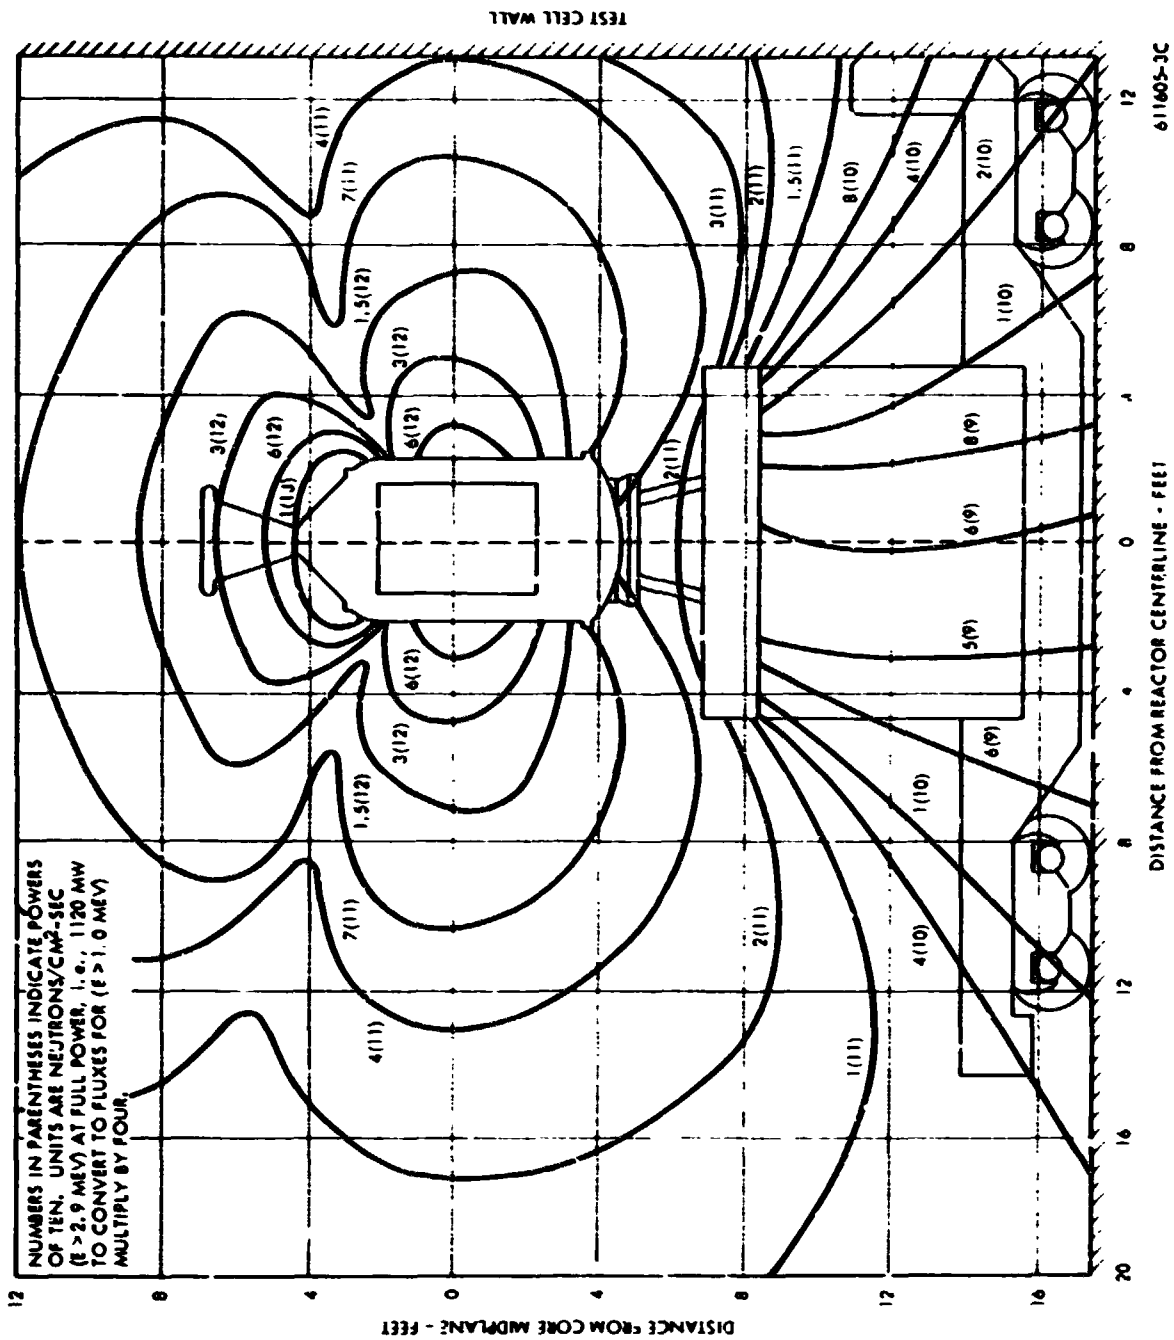
Figure 17. Fast Neutron ( $E > 2.9$  Mev) Iso-Flux Pattern Around a Typical NRX Reactor in Test Cell "A"

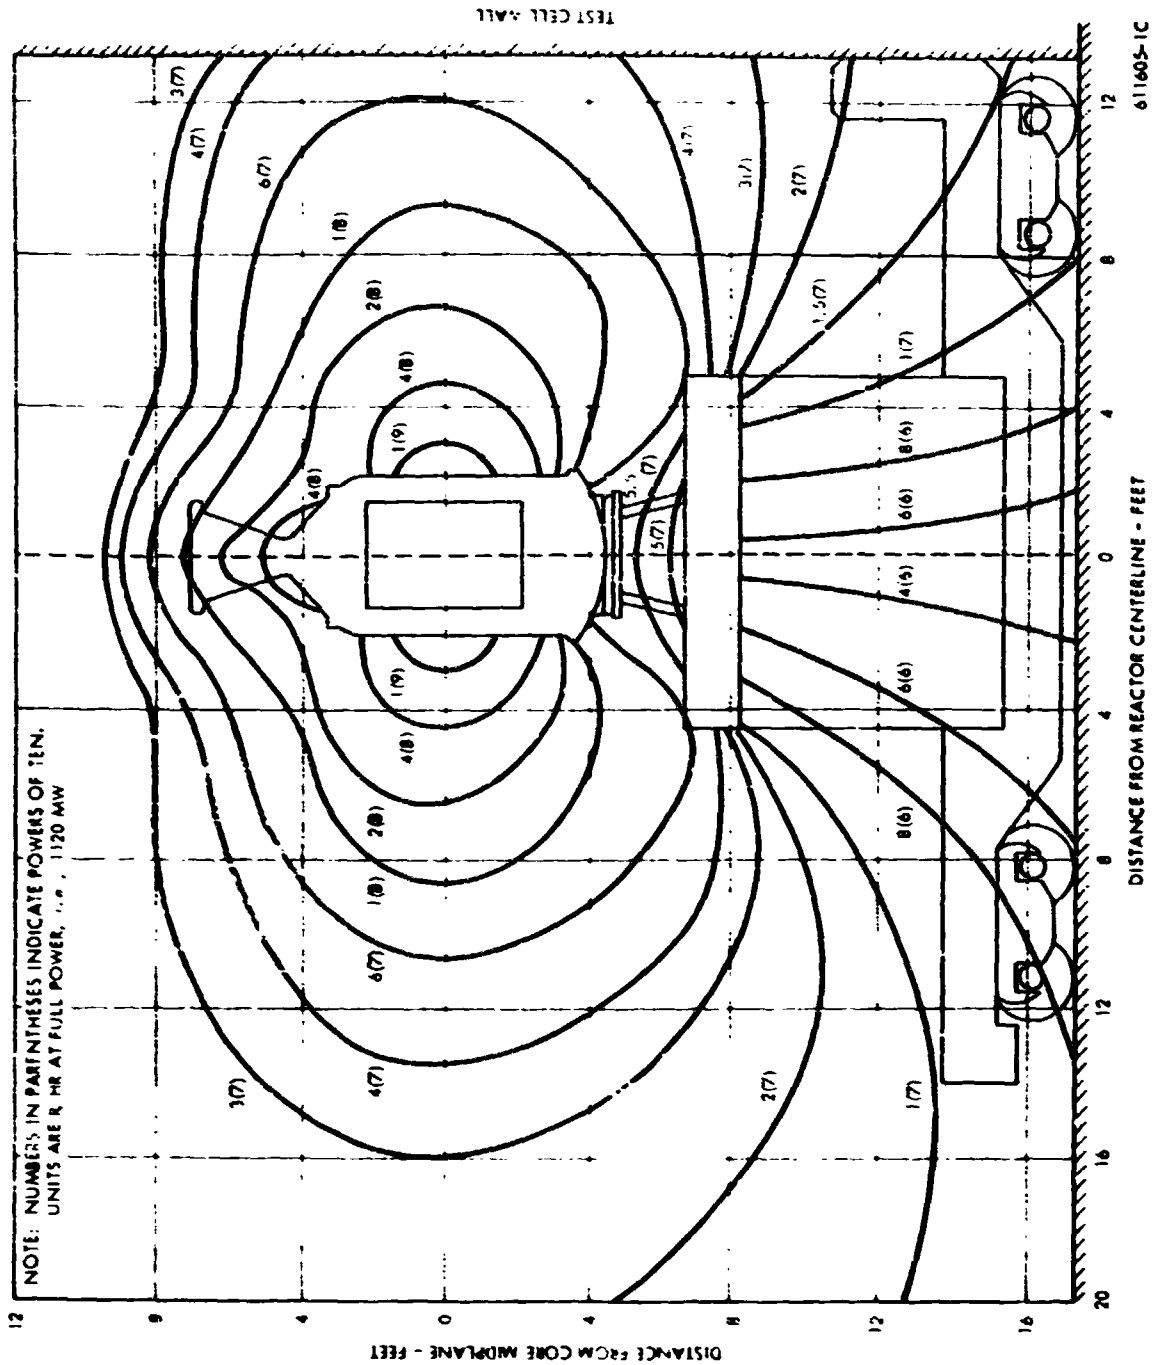
Figure 18. Gamma Ray Iso-Dose Pattern Around a Typical NRX Reactor In Test Cell "A"

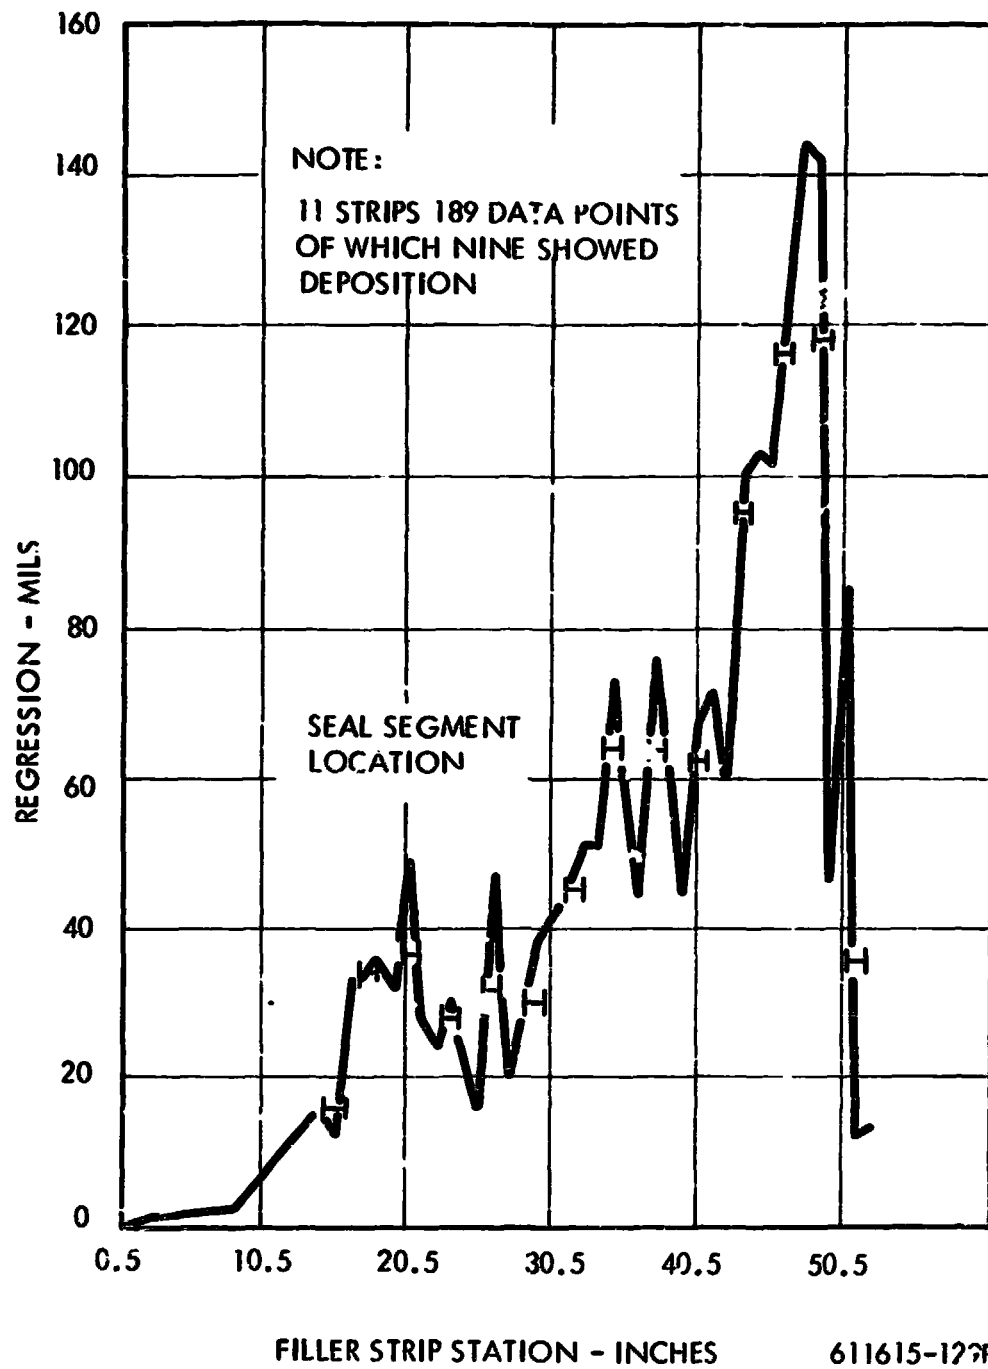
Figure 20. Filler Strip Surface Regression In Hot Buffer Area

In addition to breakage of hot buffer filler strips, approximately ten (10) hot buffer tiles were broken in the aft end retention notch. The tiles sustained mild corrosion and sooting along edges and on filler strip contact surfaces. This corrosion condition was observed on tiles as far upstream as Station 12. The appearance of the filler strip region, at the junction of the

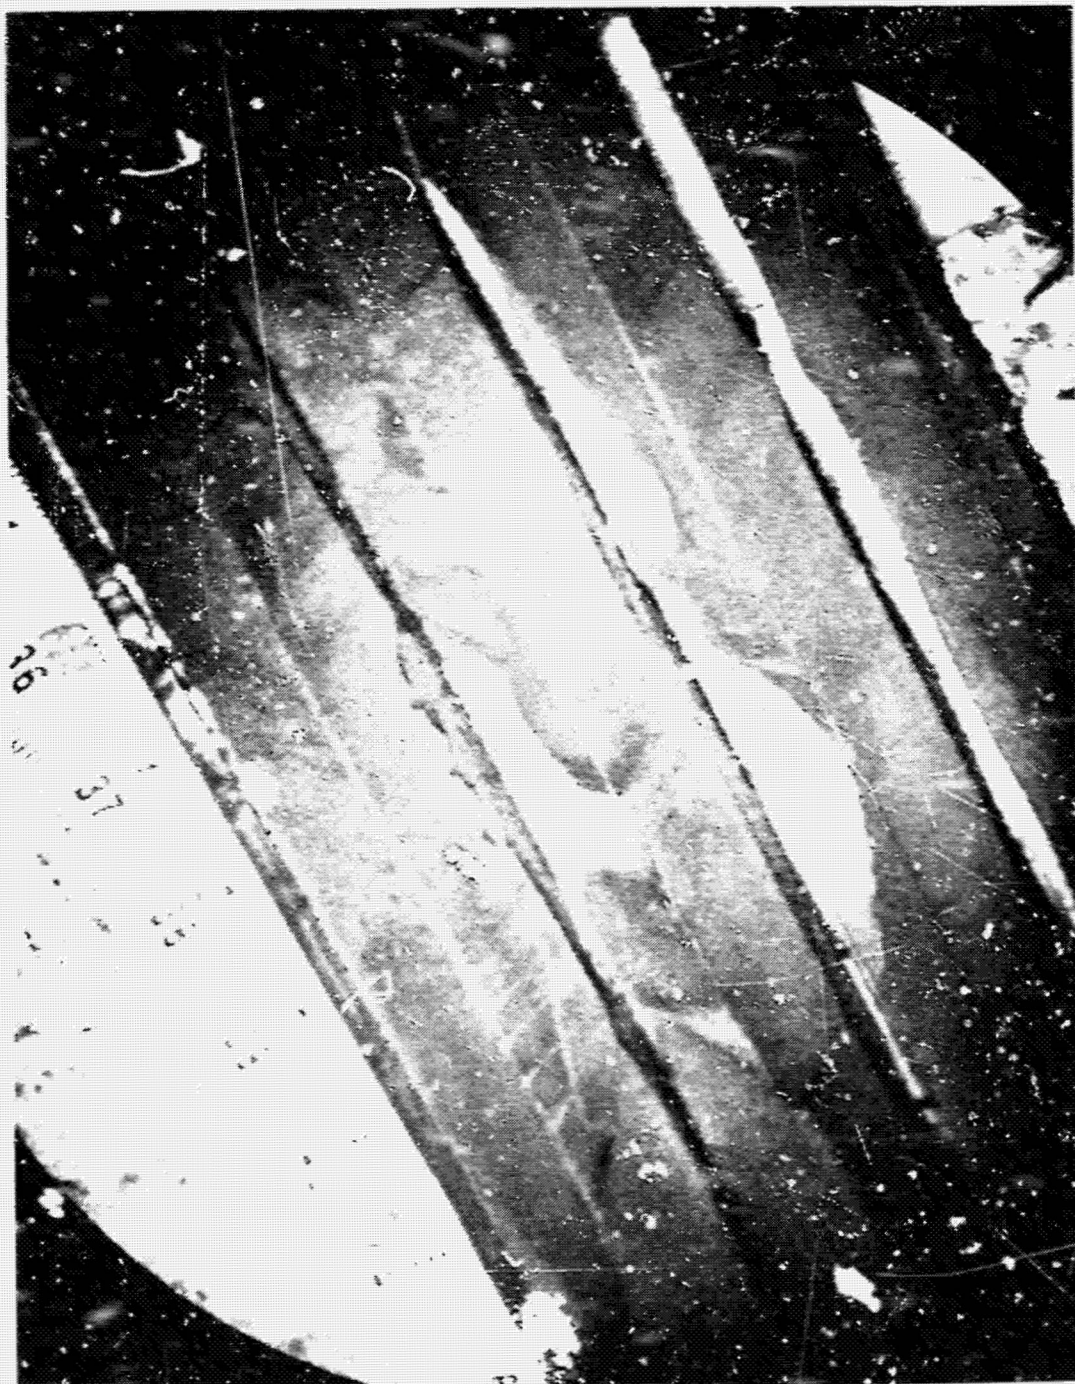
Figure 21. Hot Buffer Filler Strip Corrosion

Transient thermal analysis of the hot buffer filler strips was performed in some detail because 39 of the 54 strips in the hot buffer region were found to be broken in one or more places during the post-operative examination. However, all the strips in the nominal region remained intact. It was hypothesized that bridging of the hot buffer filler strips occurred during reactor shutdown. The temperature differential between bridged filler strips resulted in severe tensile stresses in some cases. The temperature differential was due to the different strip thicknesses. An analysis of the EP-IV shutdown transient, performed for a 30 degree sector of the hot buffer filler strips resulted in a maximum calculated temperature difference of  $600^{\circ}\text{P}$  between the sector average and the coldest strip at Station 38 inches.
